PUBLISHED PROJECT REPORT PPR675

Performance Assessment of E-Spott Ground Penetrating Radar System

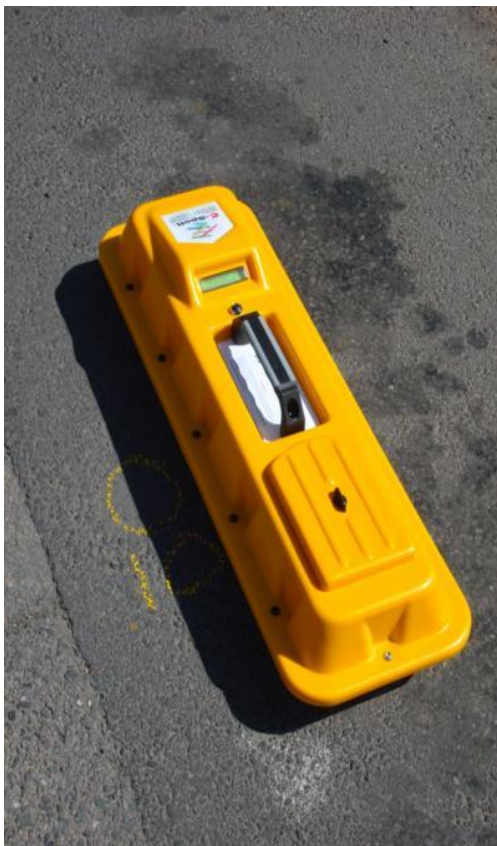
Figure 1 - The E-Spott

The E-spott unit is constructed from ABS plastic, with a white base and yellow upper half (Figure 1, left). It is powered by AA batteries, which can be rechargeable. Its user interface consists of a single momentary push button, which activates the unit and triggers a reading. A two-line alphanumeric LCD display provides readings as well as information relating to the status of the device.

The system records its measurements to an SD card in a CSV format file. The batteries and SD card slot (along with a RS232 port which is assumed to be for system maintenance and upgrade) are located under a cover which is retained by a latch. The E-spott can be

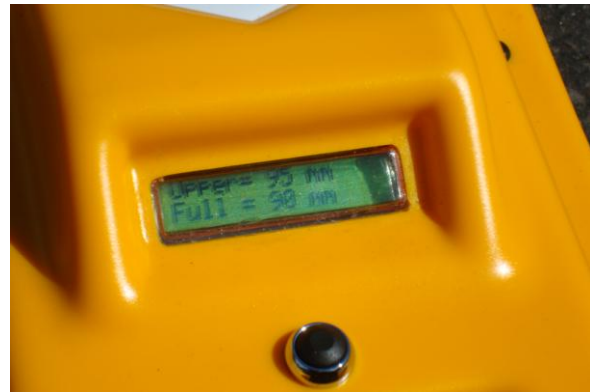
Figure 2 - E-spott data display

The system returns two readings with each measurement, displayed as 'upper' and 'full'. Figure 2 shows an example reading shown on the LCD display. The readings are obtained from the same GPR data although it is understood that slightly different algorithms are used to interrogate the data to obtain the two readings.

The 'full' reading refers to the depth of the strongest (in terms of amplitude) reflection received from within the whole of the time/depth window, which is approximately 600mm in asphalt. The 'upper' reading refers to the depth of the strongest reflection from an interface within the upper 25% of the time/depth window, approximately 150mm in asphalt. Usually the system will return two different interfaces for the upper and full measurements. For example, if there is a particularly strong internal interface within the bound material or the bound material is less than 150mm total but there is a particularly strong interface in the pavement foundations. For this reason it is necessary for the operator (or the data user) to have some knowledge of the likely construction of the pavement under test.

The system is set to ignore interfaces detected within the upper 70mm, due to possible conflict with the direct wave path. If the system cannot find a discernable interface within the upper 150mm, the 'upper' reading will simply display "****" to indicate a null value. Should the strongest interface within the total time/depth window also be within the upper 150mm time/depth window the readings will indicate the same interface. However, when this is the case the two readings are not always identical. In this case the manufacturer recommends that the upper reading should be used as this is a more sensitive algorithm for shallow depths.
